**Flood Control Project Maintenance
Levee Inspections**
LMA District Cover Sheet
Spring 2017 Levee Inspection Results

Reclamation District No. 2031 Elliot

Spring 2017 Levee Inspection Results

Waterway			Bank	Unit Miles
Unit No. 01 Stanislaus River			Left	7.07
	Spring (March - May)	Summer (June - August)	(September - November) Fall	Winter (December - February)
Unit Maintenance Rating (Fall Only)				
Date of Inspection	4/25/2017 - 4/25/2017			
DWR Inspector	Maksim Khashchuk			
Accompanied By	Arvid Carlson RD2031

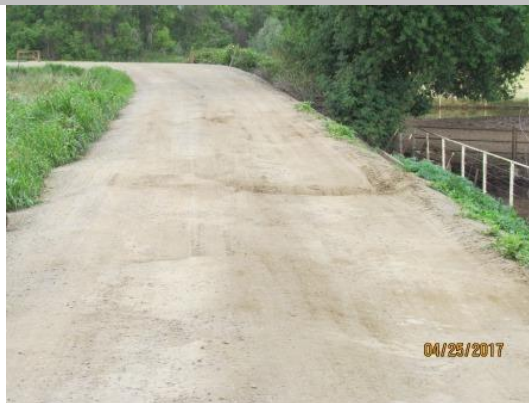
Photo 1 of 1 : SP_2017_RD2031_307_18_20170427_00110.jpg

LM Start	0.03	Rating **	M	Issue No.	18
LM End	0.03	Issue Type +	Ma	Location *	CR
Category	Earthen Levee			GPS Latitude/Longitude	
				Start	End
Item	Crown Surface / Depressions / Rutting			37.709989 °	37.709989 °
				-121.155892 °	-121.155892 °
DWR ID	DWR_RD2031_01_s_2017_18				
Comment Code					
C2 : Repair depressions or ruts in the crown or slope.					
Inspector Comment					
Add appropriate fill to pot hole to bring levee crown back to grade.

View of the potholes on the levee crown.

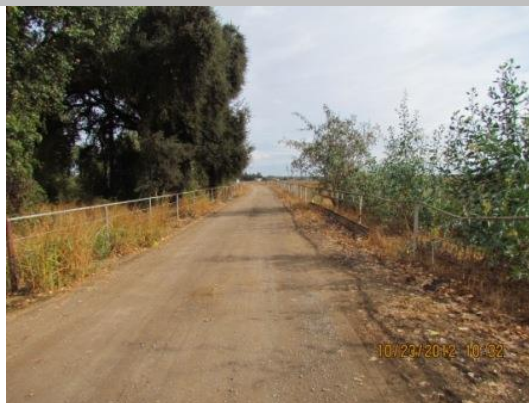
Photo 2 of 3 : SP_2017_RD2031_307_7_20170407_00010.jpg

View of fence obstructing access to waterside slope. Facing upstream.

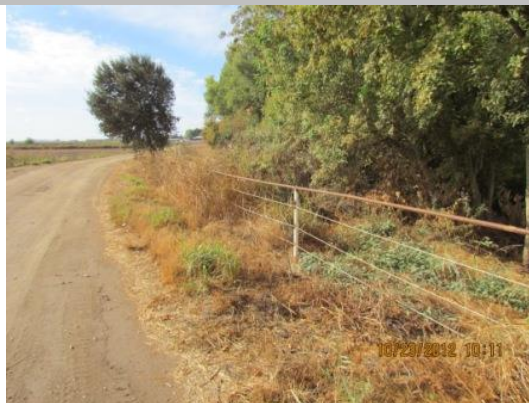
Photo 3 of 3 : SP_2017_RD2031_307_7_20170407_00011.jpg

View of fence on waterside slope facing downstream.

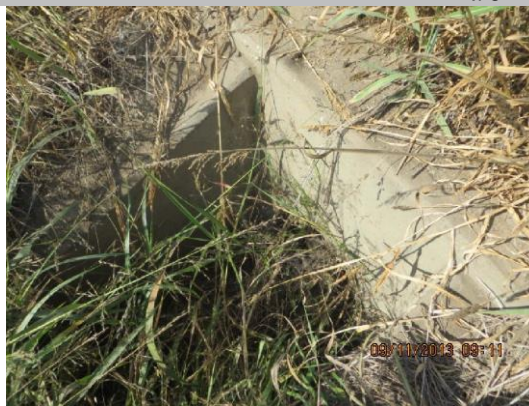
Photo 1 of 2 : UCIP_SP_2017_20024_33924.jpg

LM Start	0.35	Rating **	A/W	Issue No.	983
LM End	0.35	Issue Type +	Ma	Location *	WS
Category	Supplemental			GPS Latitude/Longitude	
				Start	End
Item	DWR UCIP LMA Responsibility			37.705932 °	37.705932 °
				-121.157985 °	-121.157985 °
DWR ID					
Comment Code					
Inspector Comment					
FS_ID:20024 DS_ID:20437 EP_NO: N/A Repair Type: No Action Needed Crossing Status: Found UCIP Comments: FIELD_STRUCT_DESC: 24-inch corrugated metal stormdrain pipe through the levee 3.5-feet below the crown. Concrete "U" headwall on both ends. Flap gate on the waterward end. Installed by UASCE, 1966. Originally included in the 1968 O&M manual. FS Date: 9/11/2013

Concrete headwall on LS slope.

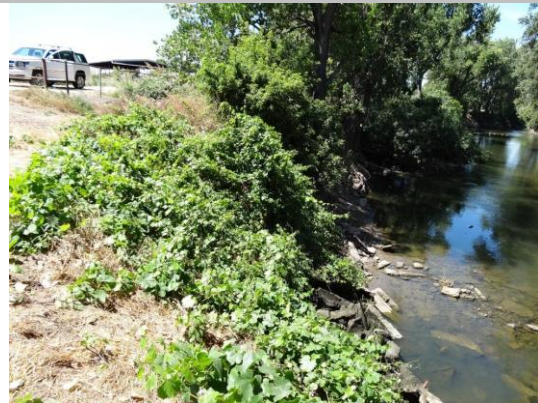
Photo 1 of 2 : SP_2017_RD2031_307_1_20170407_00001.jpg

Comment Code					
Inspector Comment					
07/25/2016: No significant change observed.					
08/28/2015: No significant change observed.					
07/31/2014: No significant change observed.					
09/10/2013: No significant change observed.					
07/18/2012: No significant change observed.					
08/18/2011: No significant change observed on site. Debris that blocks the irrigation outlet is visible.					
10/19/2010: No significant change observed on site. Sloughing of the bank is occurring adjacent to an irrigation outlet structure. There is moderate to heavy vegetation along the bank that is well established. Broken chunks and slabs of concrete are used as rip rap and line the outside of the irrigation outlet structure. However, much of the rip rap along the slope is sloughing and could possibly lead to future slope instability.					
08/05/2010: Recommended as a local maintenance issue, per CLRO.					
08/20/2009: No major change observed since last visit; 1 inch fissure cracks developing on the slope; rip rap is showing signs of sloughing; recommend as local maintenance issue; site was previously rated "U".

Direct view of the site.

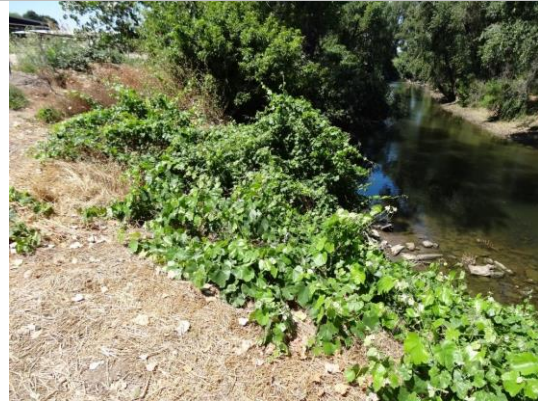
Photo 2 of 2 : SP_2017_RD2031_307_1_20170407_00002.jpg

Comment Code					
Inspector Comment					
07/25/2016: No significant change observed.					
08/28/2015: No significant change observed.					
07/31/2014: No significant change observed.					
09/10/2013: No significant change observed.					
07/18/2012: No significant change observed.					
08/18/2011: No significant change observed on site. Debris that blocks the irrigation outlet is visible.					
10/19/2010: No significant change observed on site. Sloughing of the bank is occurring adjacent to an irrigation outlet structure. There is moderate to heavy vegetation along the bank that is well established. Broken chunks and slabs of concrete are used as rip rap and line the outside of the irrigation outlet structure. However, much of the rip rap along the slope is sloughing and could possibly lead to future slope instability.					
08/05/2010: Recommended as a local maintenance issue, per CLRO.					
08/20/2009: No major change observed since last visit; 1 inch fissure cracks developing on the slope; rip rap is showing signs of sloughing; recommend as local maintenance issue; site was previously rated "U".

View of the current condition of the bank slope just above the irrigation outlet.

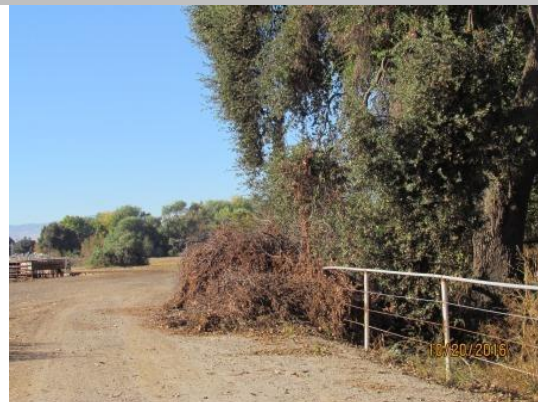
Photo 1 of 3 : SP_2017_RD2031_307_2_20170407_00003.jpg

LM Start	0.48	Rating **	U	Issue No.	2
LM End	0.51	Issue Type +	Ma	Location *	WS
Category	Earthen Levee			GPS Latitude/Longitude	
				Start	End
Item	Vegetation			37.704385 °	37.704050 °
				-121.159217 °	-121.159578 °
DWR ID	DWR_RD2031_01_s_2012_2				
Comment Code					
V2 : Remove the wild growth other than native grasses from the levee slopes.					
Inspector Comment					
Remove vegetation 20 feet away from the levee crown.

View of the large tree branch on the waterside levee slope. Fall 2016

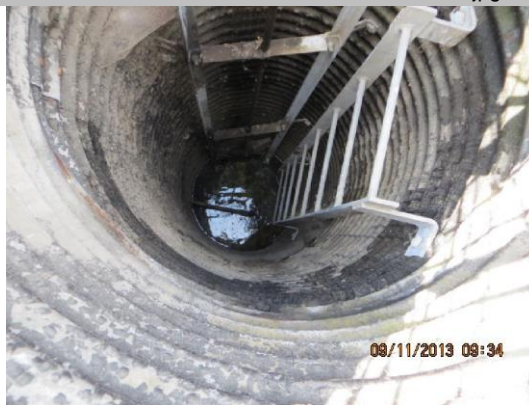
Photo 2 of 3 : UCIP_SP_2017_20044_33941.jpg

LM Start	0.56	Rating **	A/W	Issue No.	984
LM End	0.56	Issue Type +	Ma	Location *	WS
Category	Supplemental			GPS Latitude/Longitude	
				Start	End
Item	DWR UCIP LMA Responsibility			37.703323 °	37.703323 °
				-121.159771 °	-121.159771 °
DWR ID					
Comment Code					
Inspector Comment					
FS_ID:20044					
DS_ID:20439					
EP_NO: N/A					
Repair Type: No Action Needed					
Crossing Status: Found					
UCIP Comments:					
FIELD_STRUCT_DESC: 15-inch corrugated metal pipe stormdrain through the levee 9.0-feet below the crown. Slide gate in 36-inch corrugated metal pipe riser on the waterward slope. Drainage canal off LS toe. Originally included in the 1968 O&M manual. This pipe replaced a 15-inch pipe at same location.					
FS Date: 9/11/2013

Slide gate in CMP riser on WS shoulder.

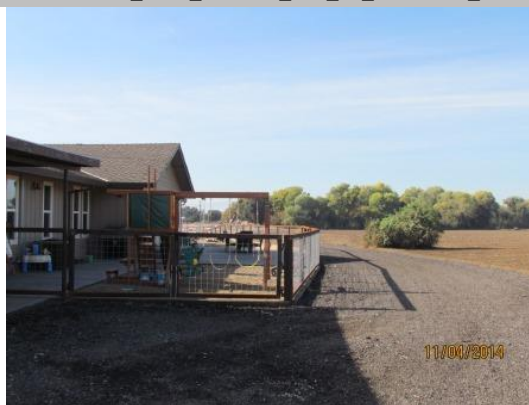
Photo 1 of 1 : SP_2017_RD2031_307_58_20170407_00041.jpg

LM Start	0.60	Rating **	M	Issue No.	58
LM End	0.63	Issue Type +	En	Location *	LS
Category	Earthen Levee			GPS Latitude/Longitude	
				Start	End
Item	Encroachments			37.703186 °	37.702786 °
				-121.160211 °	-121.160628 °
DWR ID	DWR_RD2031_01_f_2014_58				
Comment Code					
FE : Fence					
Inspector Comment					
Unpermitted fence on landside levee hinge.

View of the unpermitted fence on the landside levee hinge.

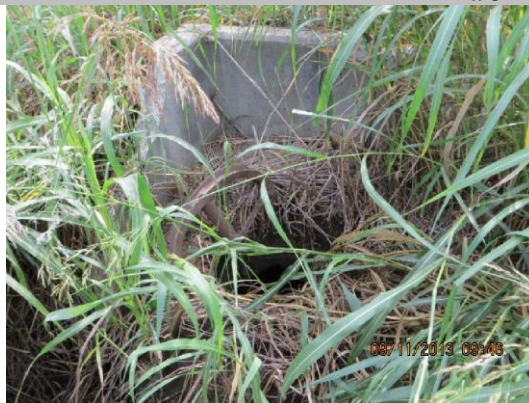
Photo 2 of 3 : UCIP_SP_2017_20046_33945.jpg

LM Start	0.72	Rating **	M	Issue No.	985 (cont)	
LM End	0.72	Issue Type +	En	Location *	LS	
Category	Supplemental			GPS Latitude/Longitude		
				Start	End	
Item	DWR UCIP Field Study			37.701912 °	37.701912 °	
				-121.161642 °	-121.161642 °	
DWR ID						
Comment Code						
Inspector Comment						
FS_ID:20046						
DS_ID:20440						
EP_NO: N/A						
Repair Type: Non-Urgent						
Crossing Status: Found						
UCIP Comments: Alfalfa valve on the WS toe is damaged.						
FIELD_STRUCT_DESC: 30-inch corrugated metal irrigation pipe						
through the levee 5.0-feet below the crown. Flashboard slots in						
concrete headwall on the landward side. Distribution box with alfalfa						
valve on the waterward side. Installed by USACE, 1966. Replaced a						
30-inch pipe at same location.						
FS Date: 9/11/2013

Concrete headwall and damaged alfalfa valve on WS toe.

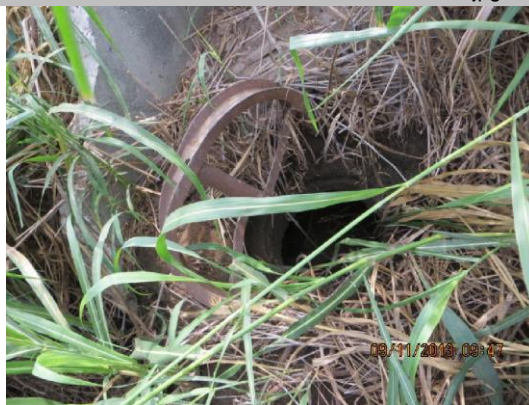
Photo 3 of 3 : UCIP_SP_2017_20046_33944.jpg

Damaged alfalfa valve.

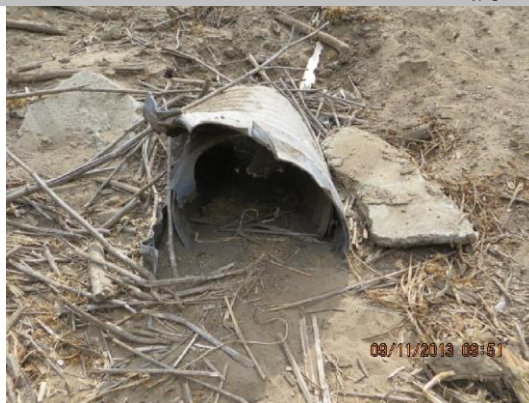
Photo 1 of 3 : UCIP_SP_2017_20047_33950.jpg

LM Start	0.75	Rating **	M	Issue No.	986
LM End	0.75	Issue Type +	En	Location *	LS
Category	Supplemental			GPS Latitude/Longitude	
				Start	End
Item	DWR UCIP Field Study			37.701552 °	37.701552 °
				-121.161883 °	-121.161883 °
DWR ID					
Comment Code					
Inspector Comment					
FS_ID:20047					
DS_ID:20441					
EP_NO: N/A					
Repair Type: Non-Urgent					
Crossing Status: Found					
UCIP Comments: This pipe appears abandoned and if so, should be done so appropriately.					
FIELD_STRUCT_DESC: 15-inch corrugated metal pipe through levee 4.0 feet below crown. Flashboard slots on the landward side. Installed by USACE 1966. Originally included in the 1968 O&M manual.					
FS Date: 9/11/2013

Damaged CMP pipe on WS slope.

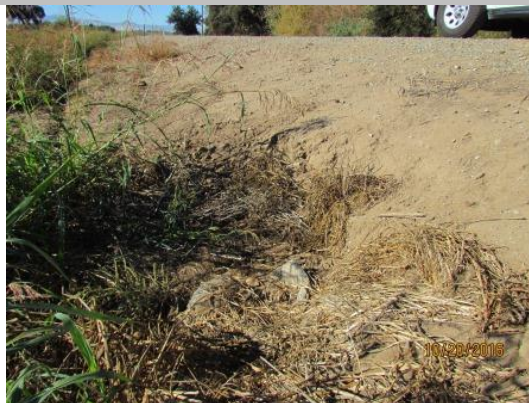
Photo 1 of 1 : SP_2017_RD2031_307_42_20170407_00027.jpg

LM Start	0.84	Rating **	M	Issue No.	42
LM End	0.84	Issue Type +	Ma	Location *	LS
Category	Earthen Levee			GPS Latitude/Longitude	
				Start	End
Item	Erosion / Bank Caving			37.700447 °	37.700447 °
				-121.162742 °	-121.162742 °
DWR ID	DWR_RD2031_01_f_2016_42				
Comment Code					
E2 : Schedule repair of erosion site prior to the next inspection.					
Inspector Comment

View of the erosion of the landside levee slope.

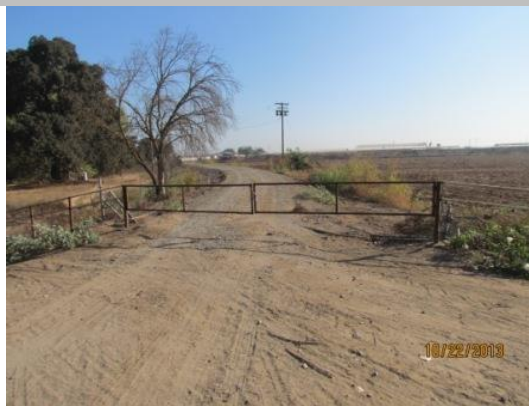
Photo 1 of 1 : SP_2017_RD2031_307_51_20170407_00035.jpg

View of the gate across levee crown.

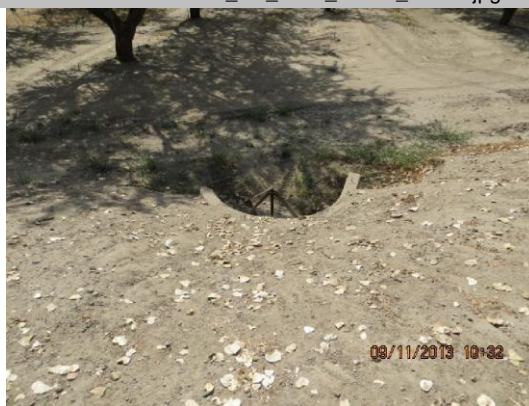
Photo 1 of 3 : UCIP_SP_2017_47158_74940.jpg

LM Start	0.92	Rating **	M	Issue No.	988
LM End	0.92	Issue Type +	En	Location *	CR
Category	Supplemental			GPS Latitude/Longitude	
				Start	End
Item	DWR UCIP Field Study			37.699692 °	37.699692 °
				-121.163977 °	-121.163977 °
DWR ID					
Comment Code					
Inspector Comment					
FS_ID:47158					
DS_ID:20444					
EP_NO: N/A					
Repair Type: Non-Urgent					
Crossing Status: Indicator Found					
UCIP Comments: Need site visit by UCIP--Concrete headwall present on landward side toe. Need to coordinate with owner to determine if this headwall is for 24-inch pipe or if the structure is part of drainage system that could run parallel to levee.					
FIELD_STRUCT_DESC: 24-inch pipe through levee 3.5 feet below crown. Flap gate on the waterward end.					
FS Date: 9/10/2013

Concrete structure located on landward side toe.

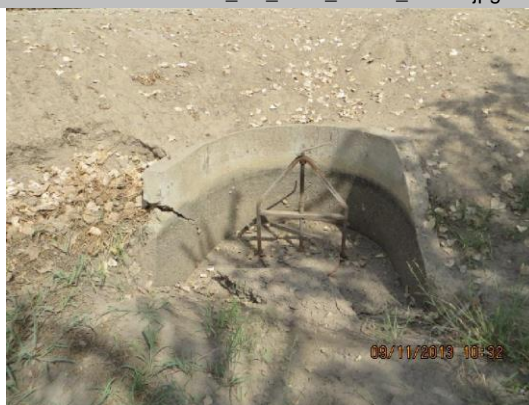
Photo 2 of 3 : UCIP_SP_2017_47158_74941.jpg

Front view of concrete structure located on landward toe.

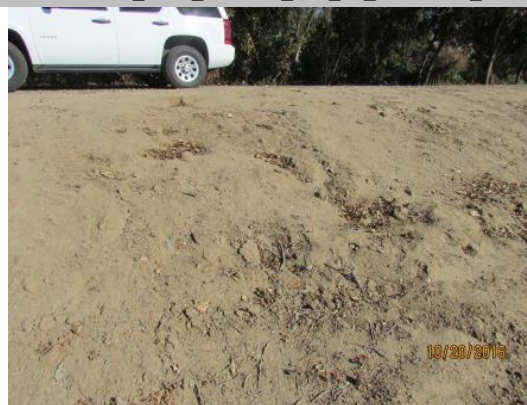
Photo 1 of 3 : SP_2017_RD2031_307_59_20170407_00042.jpg

View of the rodent holes on the landside levee slope.

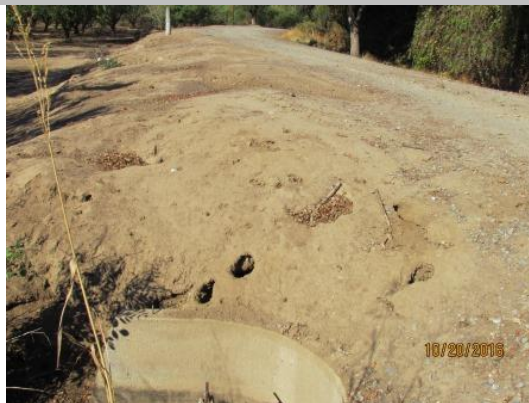
Photo 2 of 2 : SP_2017_RD2031_307_44_20170407_00029.jpg

Another view of the rodent holes on the landside levee slope.

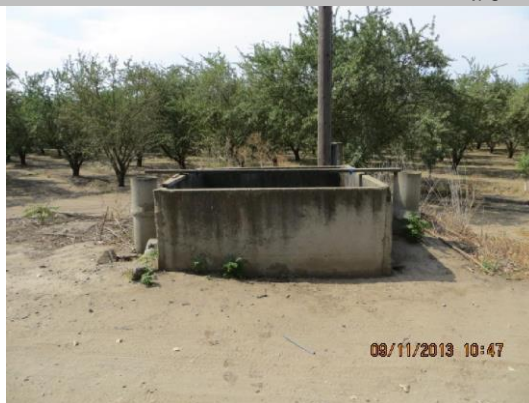
Photo 1 of 3 : UCIP_SP_2017_20085_34010.jpg

LM Start	1.27	Rating **	M	Issue No.	989
LM End	1.27	Issue Type +	En	Location *	LS
Category	Supplemental			GPS Latitude/Longitude	
				Start	End
Item	DWR UCIP Field Study			37.699480 °	37.699480 °
				-121.169850 °	-121.169850 °
DWR ID					
Comment Code					
Inspector Comment					
FS_ID:20085					
DS_ID:20445					
EP_NO: N/A					
Repair Type: Non-Urgent					
Crossing Status: Found					
UCIP Comments: Pipe corroded through at distribution box. Appears abandoned and should be done so properly.					
FIELD_STRUCT_DESC: 1 of 2: 12-inch steel pipe through the levee 3.3-feet below the crown. Pump missing from pile structure on the riverbank. Concrete distribution box on the landward side. Installed by USACE, 1966. Also included in 1968 O&M manual.					
FS Date: 9/11/2013

Concrete distribution box on LS shoulder.

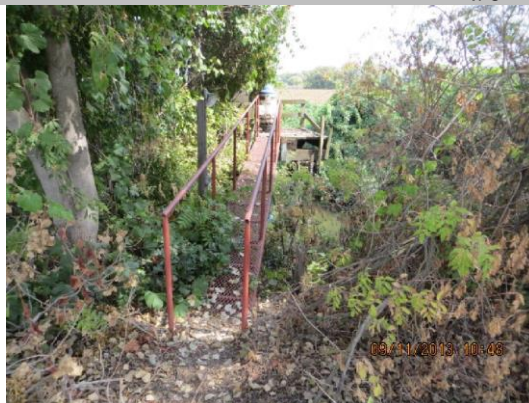
Photo 2 of 3 : UCIP_SP_2017_20085_34009.jpg

LM Start	1.27	Rating **	M	Issue No.	989 (cont)
LM End	1.27	Issue Type +	En	Location *	LS
Category	Supplemental			GPS Latitude/Longitude	
				Start	End
Item	DWR UCIP Field Study			37.699480 °	37.699480 °
				-121.169850 °	-121.169850 °
DWR ID					
Comment Code					
Inspector Comment					
FS_ID:20085					
DS_ID:20445					
EP_NO: N/A					
Repair Type: Non-Urgent					
Crossing Status: Found					
UCIP Comments: Pipe corroded through at distribution box. Appears abandoned and should be done so properly.					
FIELD_STRUCT_DESC: 1 of 2: 12-inch steel pipe through the levee 3.3-feet below the crown. Pump missing from pile structure on the riverbank. Concrete distribution box on the landward side. Installed by USACE, 1966. Also included in 1968 O&M manual.					
FS Date: 9/11/2013

Pump on pier on WS slope.

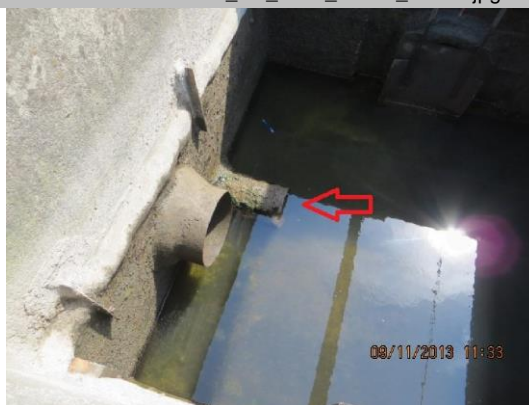
Photo 3 of 3 : UCIP_SP_2017_20085_34008.jpg

Pipe visible inside concrete distribution box on LS shoulder.

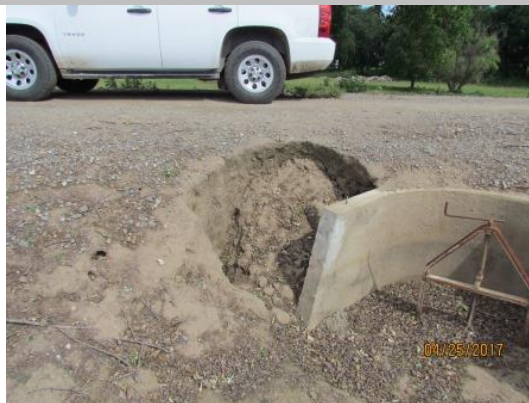
Photo 1 of 1 : SP_2017_RD2031_307_62_20170427_00113.jpg

View of the erosion on the levee slope penetrating levee prism.

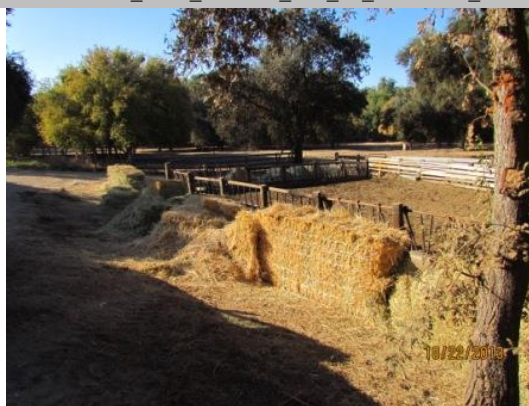
Photo 1 of 1 : SP_2017_RD2031_307_37_20170407_00024.jpg

View of the hay bails at the waterside levee toe.

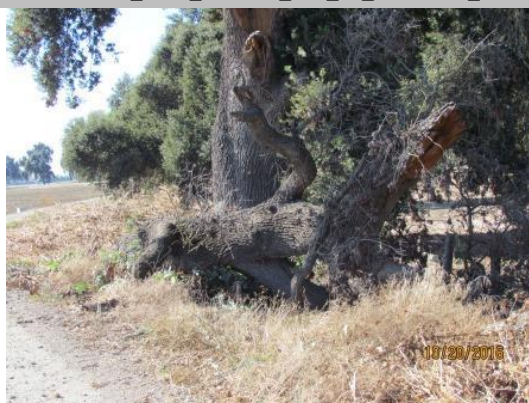
Photo 1 of 1 : SP_2017_RD2031_307_46_20170407_00031.jpg

View of the broken tree limb on the waterside levee slope.

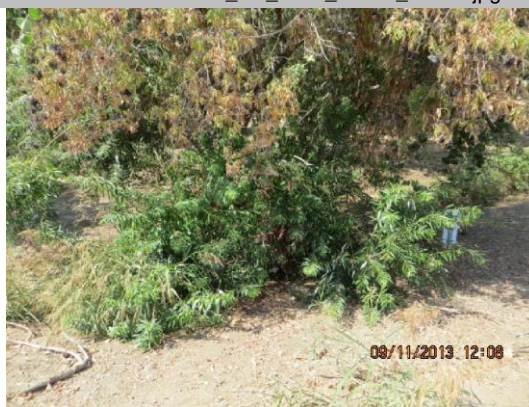
Photo 2 of 3 : UCIP_SP_2017_20110_34077.jpg

Vegetation covers outlet of pipe on WS slope.

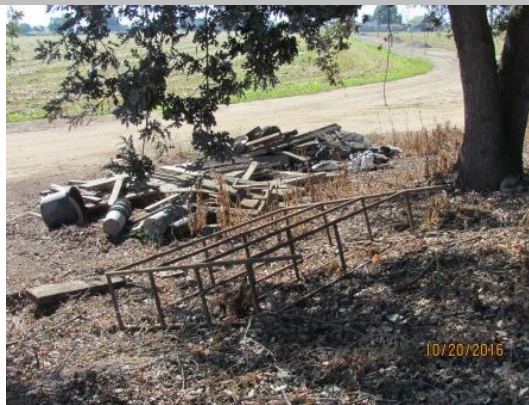
Photo 1 of 2 : SP_2017_RD2031_307_53_20170407_00037.jpg

View of the debris at the landside levee toe.

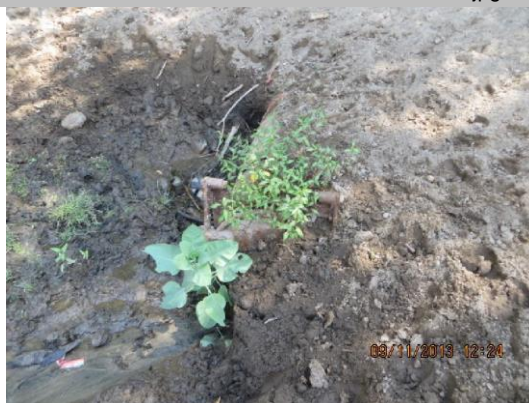
Photo 3 of 3 : UCIP_SP_2017_51340_39001.jpg

Flapgate partially blocked by soil on WS toe.

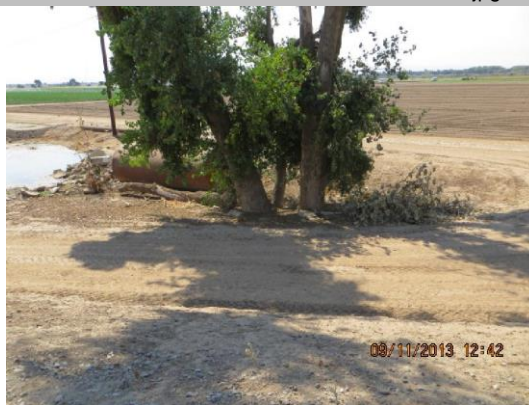
Photo 2 of 3 : UCIP_SP_2017_20449_34505.jpg

Pipe not visible on LS toe.

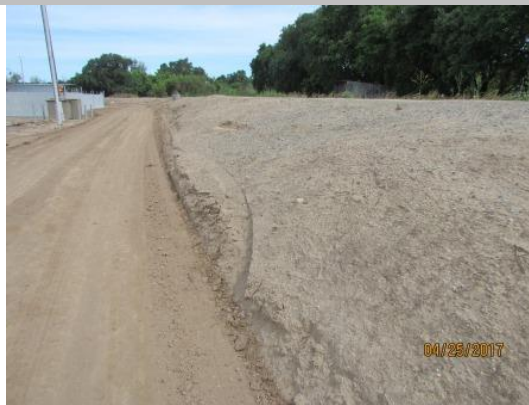
Photo 1 of 1 : SP_2017_RD2031_307_55_20170427_00120.jpg

View of the levee toe cut. Looking downstream.

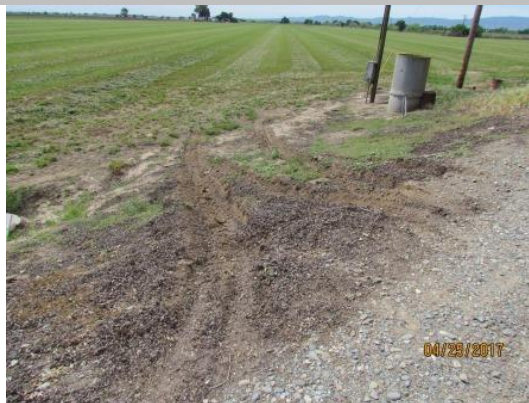
Photo 1 of 1 : SP_2017_RD2031_307_69_20170427_00121.jpg

View of the tire ruts on the levee slope.

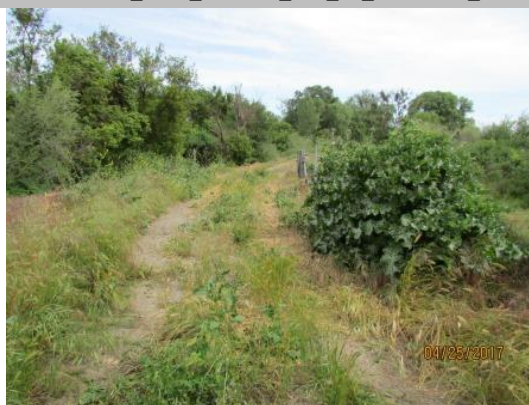
Photo 1 of 1 : SP_2017_RD2031_307_70_20170427_00123.jpg

View of the tall vegetation on the levee crown and slope.

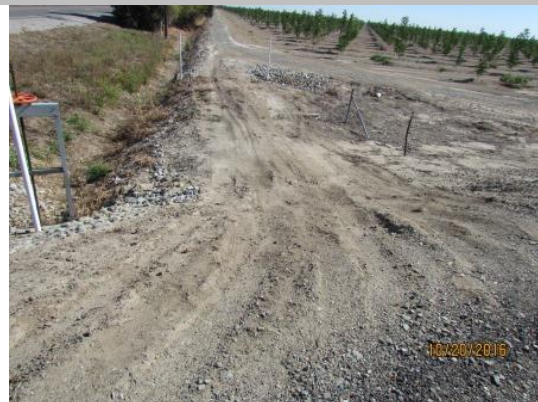
Photo 1 of 1 : SP_2017_RD2031_308_17_20170407_00005.jpg

View of the tire tracks on the levee slope.

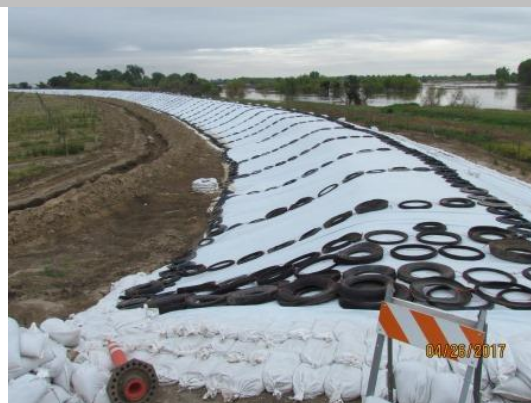
Photo 1 of 1 : SP_2017_RD2031_308_28_20170427_00052.jpg

View of the raincoat and seepage catch ditch near the levee.

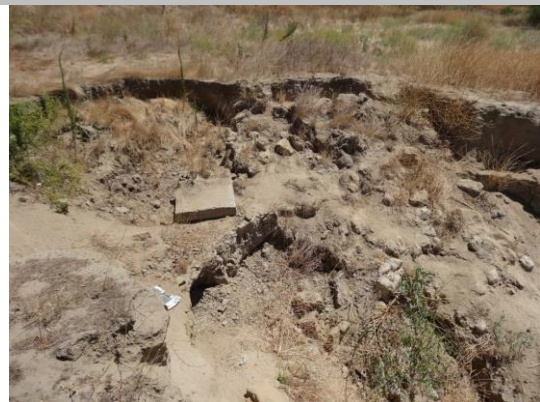
Photo 2 of 3 : SP_2017_RD2031_308_1_20170407_00002.jpg

Close view of the pocket erosion.

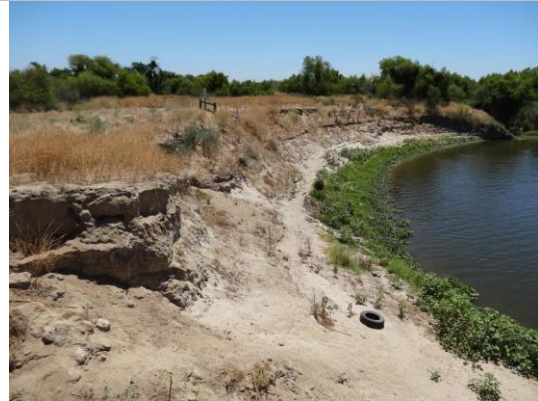
Photo 3 of 3 : SP_2017_RD2031_308_1_20170407_00003.jpg

Close view of the erosion.
